NATIONAL DAM SAFETY PROGRAM. BAYMAN DAM - NO NAME 381 (NO 20240--ETC(U)

NONAME 381  
JACKSON COUNTY, MISSOURI  
MO 20240

## PHASE 1 INSPECTION REPORT NATIONAL DAM SAFETY PROGRAM

AUGUST 1978

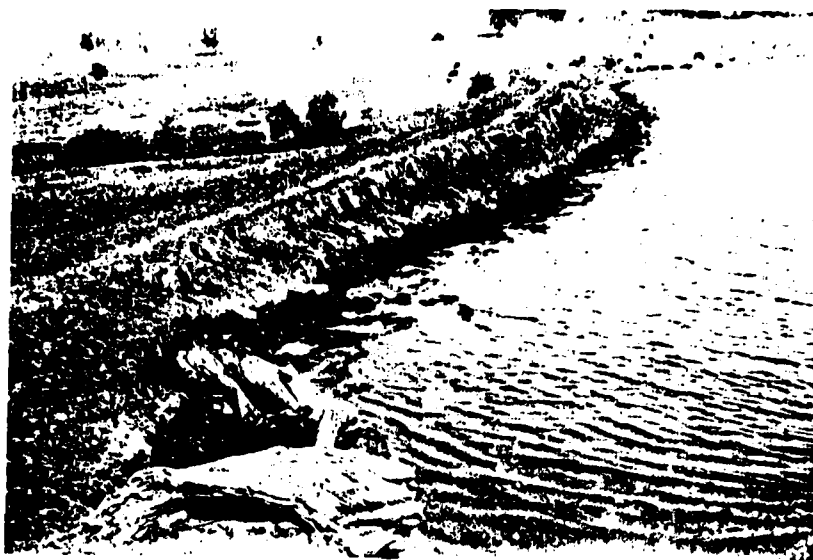
b. Dam. The inspection team observed the following items at the dam. Some erosion was noted on the upstream embankment which had no slope protection. The horizontal and vertical alinements were very irregular. This irregularity may be attributed to post construction repairs and enlargement. Sliding, cracking, or seepage were not observed at the time of inspection. The embankment was observed to be in generally good condition except an emergency spillway had not been provided. Geologic features which affect the engineering aspects of the site, such as type of rock, jointing, solution activity, and bedding, were not observed nor found at the time of inspection.

a. Safety. The only item of concern noted during the visual inspection which should be monitored or controlled was the presence of severe erosion along the upstream face of the dam.

PHOTO 1: UPSTREAM FACE OF DAM (LOOKING NORTH)

(1) Erosion should be repaired and riprap added on the upstream face to prevent additional erosion.

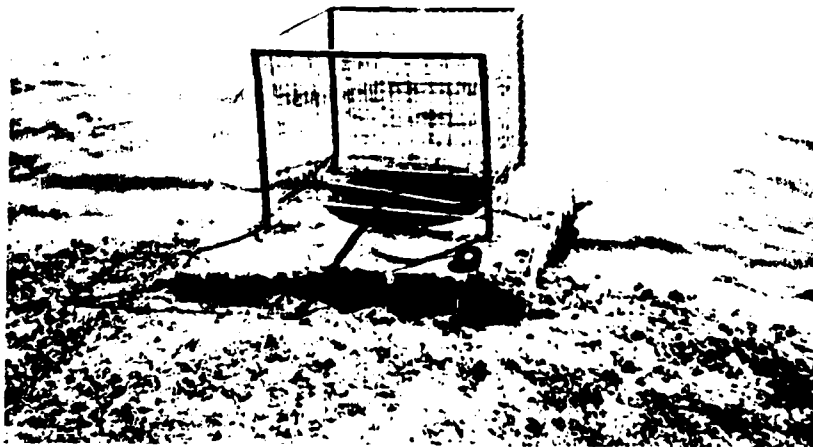
c. Appurtenant Structures. The spillway is a 36 inch diameter vertical concrete pipe which discharges through a 30 inch diameter concrete pipe located at the toe of the downstream embankment.

(1) The concrete shaft spillway is in good condition. Although there was no riprap at the outlet of the spillway, the discharge channel appeared in good condition with little erosion.

PHOTO 3: SHAFT SPILLWAY INLET
